WBIA Industry Days Recovery Boiler Presentation Appleton, WI.

Presented by Bob DeCaigny

April 24, 2013

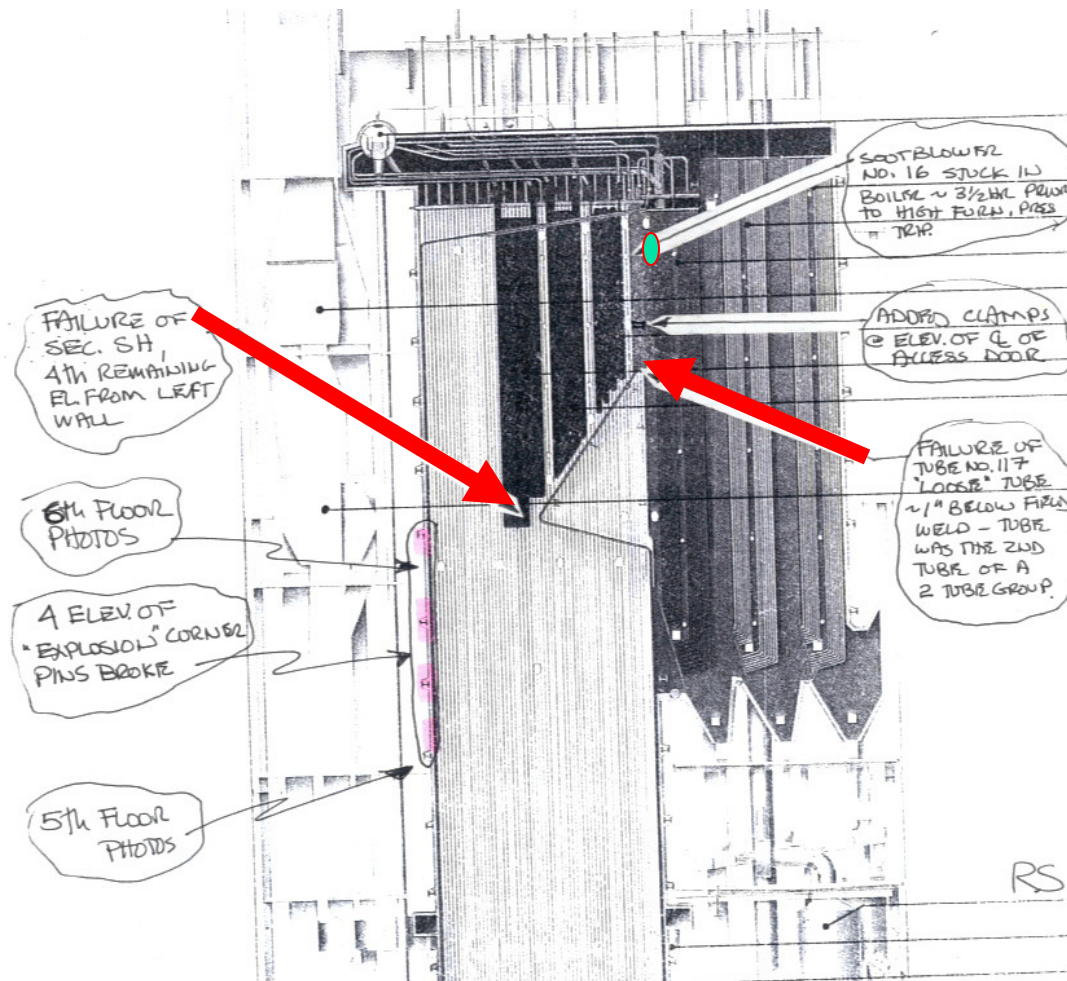
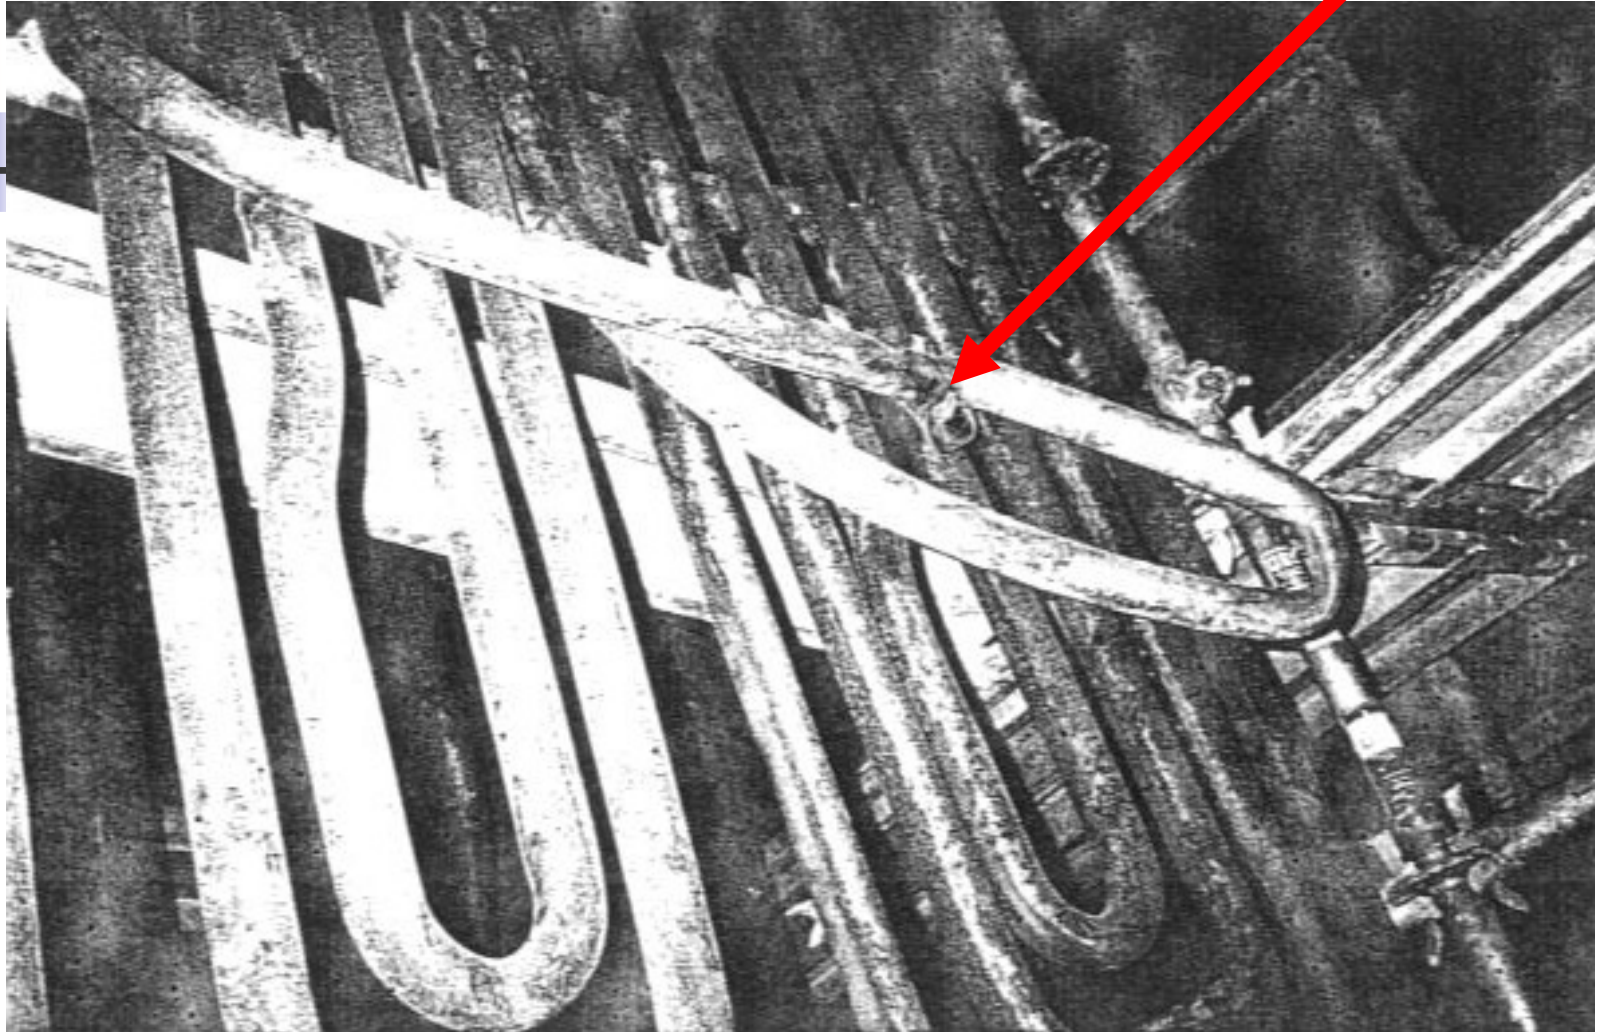
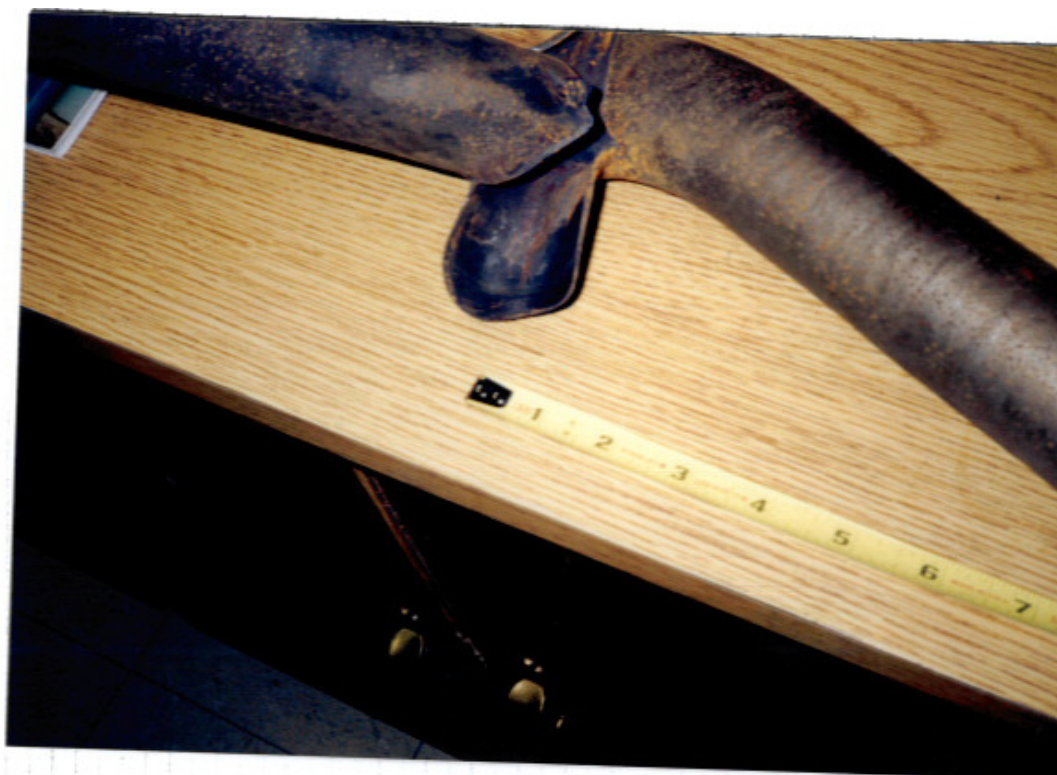
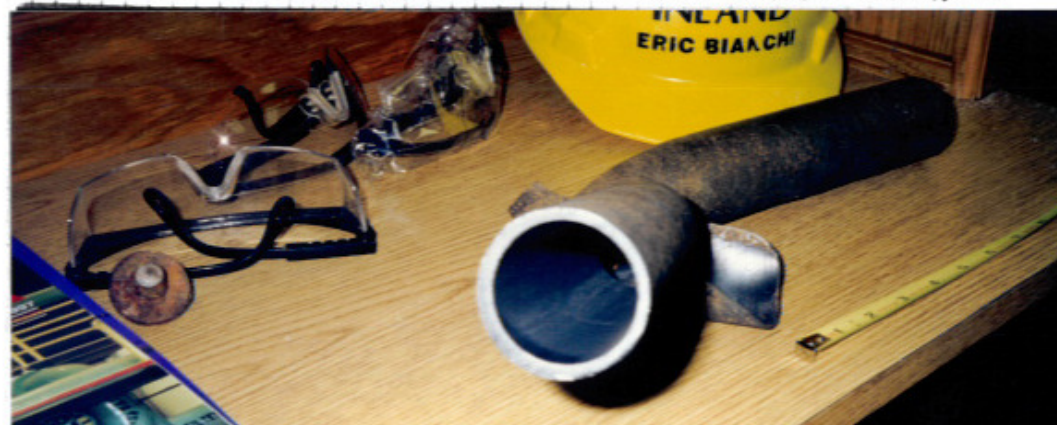
S-W Event #15 Pictures

15. Sootblower stuck about mid-travel in the rear wall screen lane. Mechanics delayed in responding and eventually removed the sootblower from the boiler. High furnace pressure trip, drum level low and using 250 mpph FW to maintain level. Got back on line burning BL, furnace pressurizing and found ruptured SH tube. Burning out bed for shutdown (steam 240 mpph, FW 450 mpph) and discovered something wrong. Open RB rapid drains but, did not ESP. 15 minutes later FW >700 mpph, tripped two motor driven FWPs but, the turbine driven pump required a manual local trip. Explosion. The walls bulged and explosion corner opened up. Minor damage, down one week.

SEC. SIX FAILURE IN 4TH REMAINING EL. FROM LEFT WR
TUBE NO. 15 NEAR LOWEST BEND IN FULLY RADIANT SECTION.

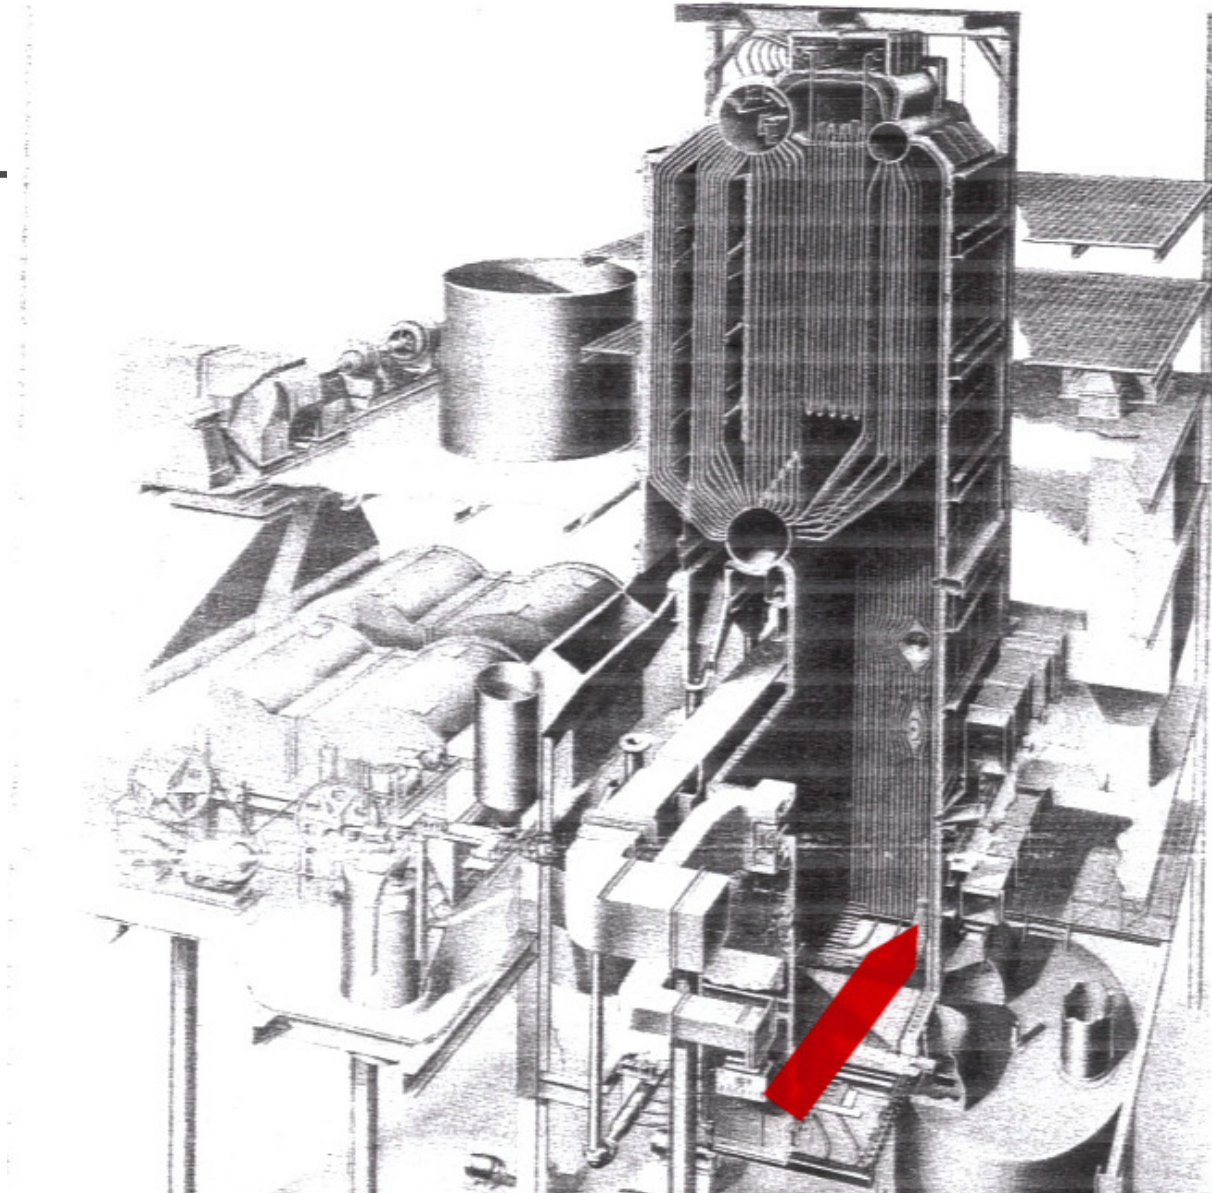
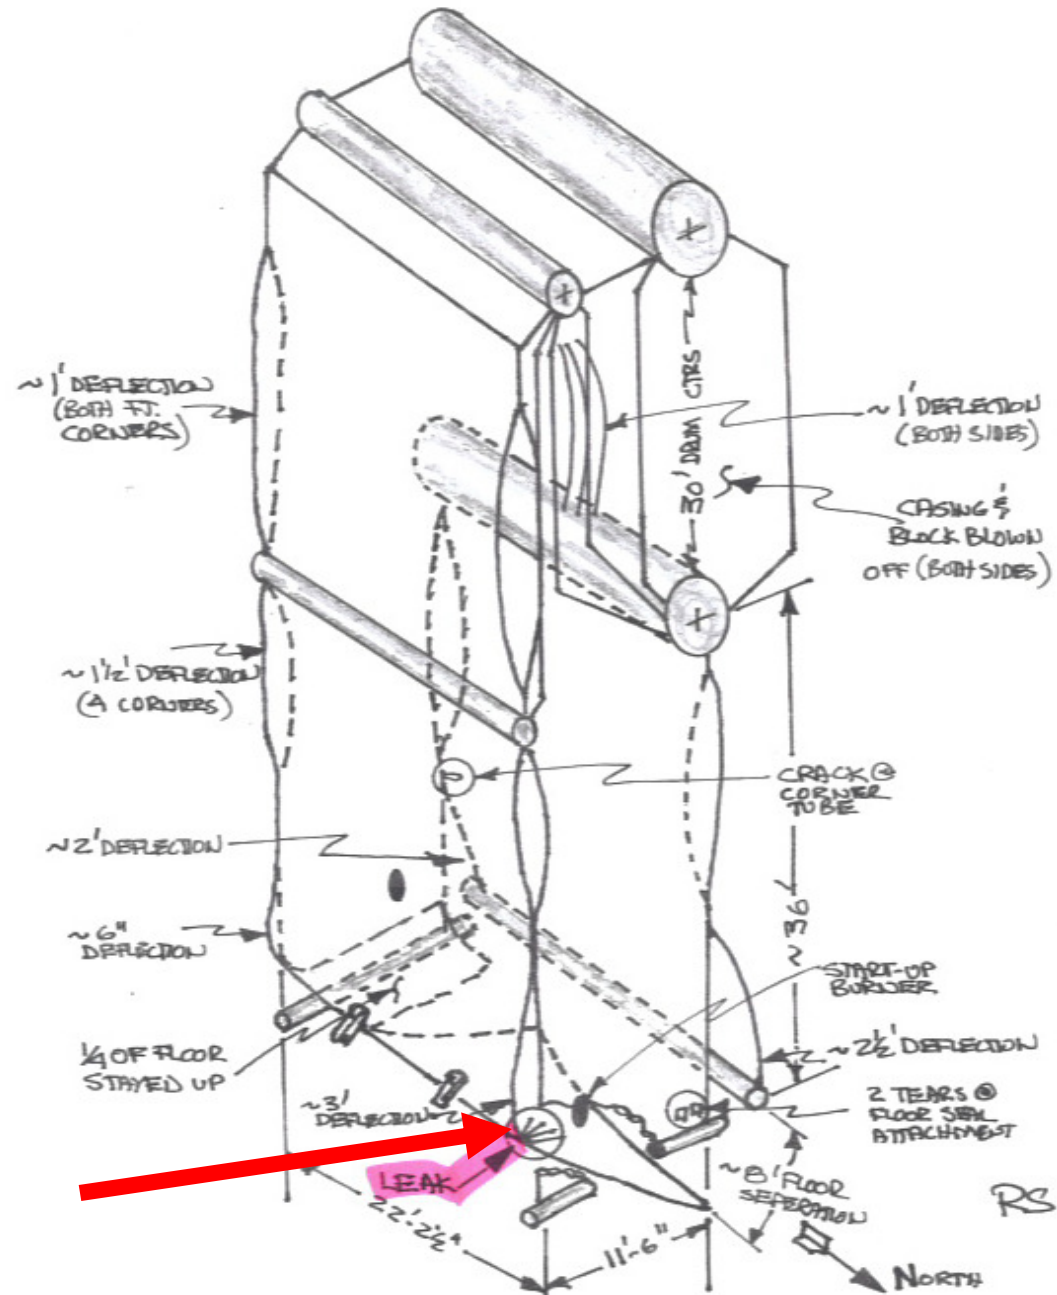
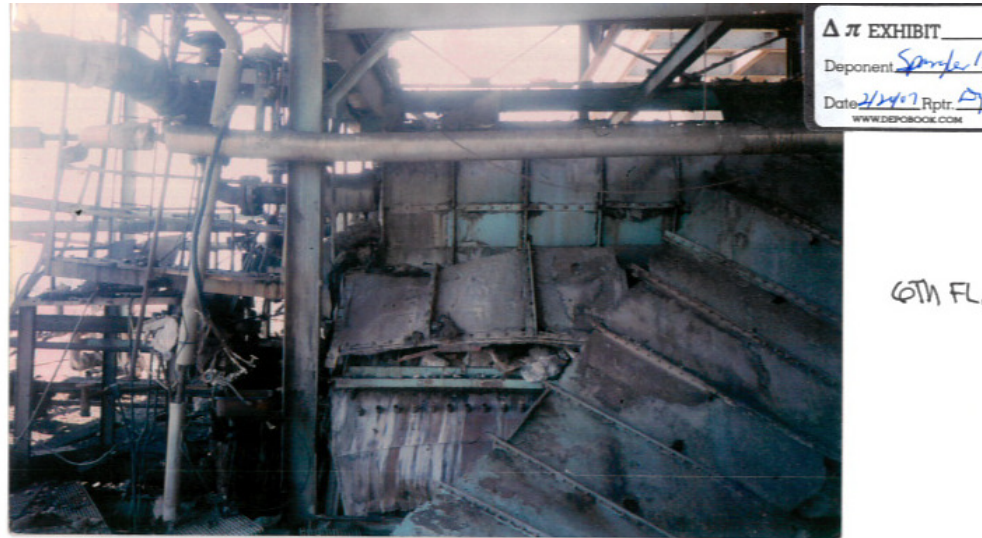
S-W Event #17 Pictures

17. BL unstable burning, noise at char bed from BL gun slag, walkdown and no leak detected. 7.5 hours later unit trips on low drum, bring back on line. Two hours later low drum trip, ID fan speed has increased by 30% and FW open 100% in manual. Reestablish drum, light an oil burner, loud explosion and ESP'd. Leak at right floor to sidewall seal plate (DWD ≈ 90 g./ft.²), all corners opened one to two feet (no explosion corner), floor separated ≈ 8 feet and the building steel was damaged. Extreme damage (fatalities and serious injury), Mill permanently shutdown (900 people).

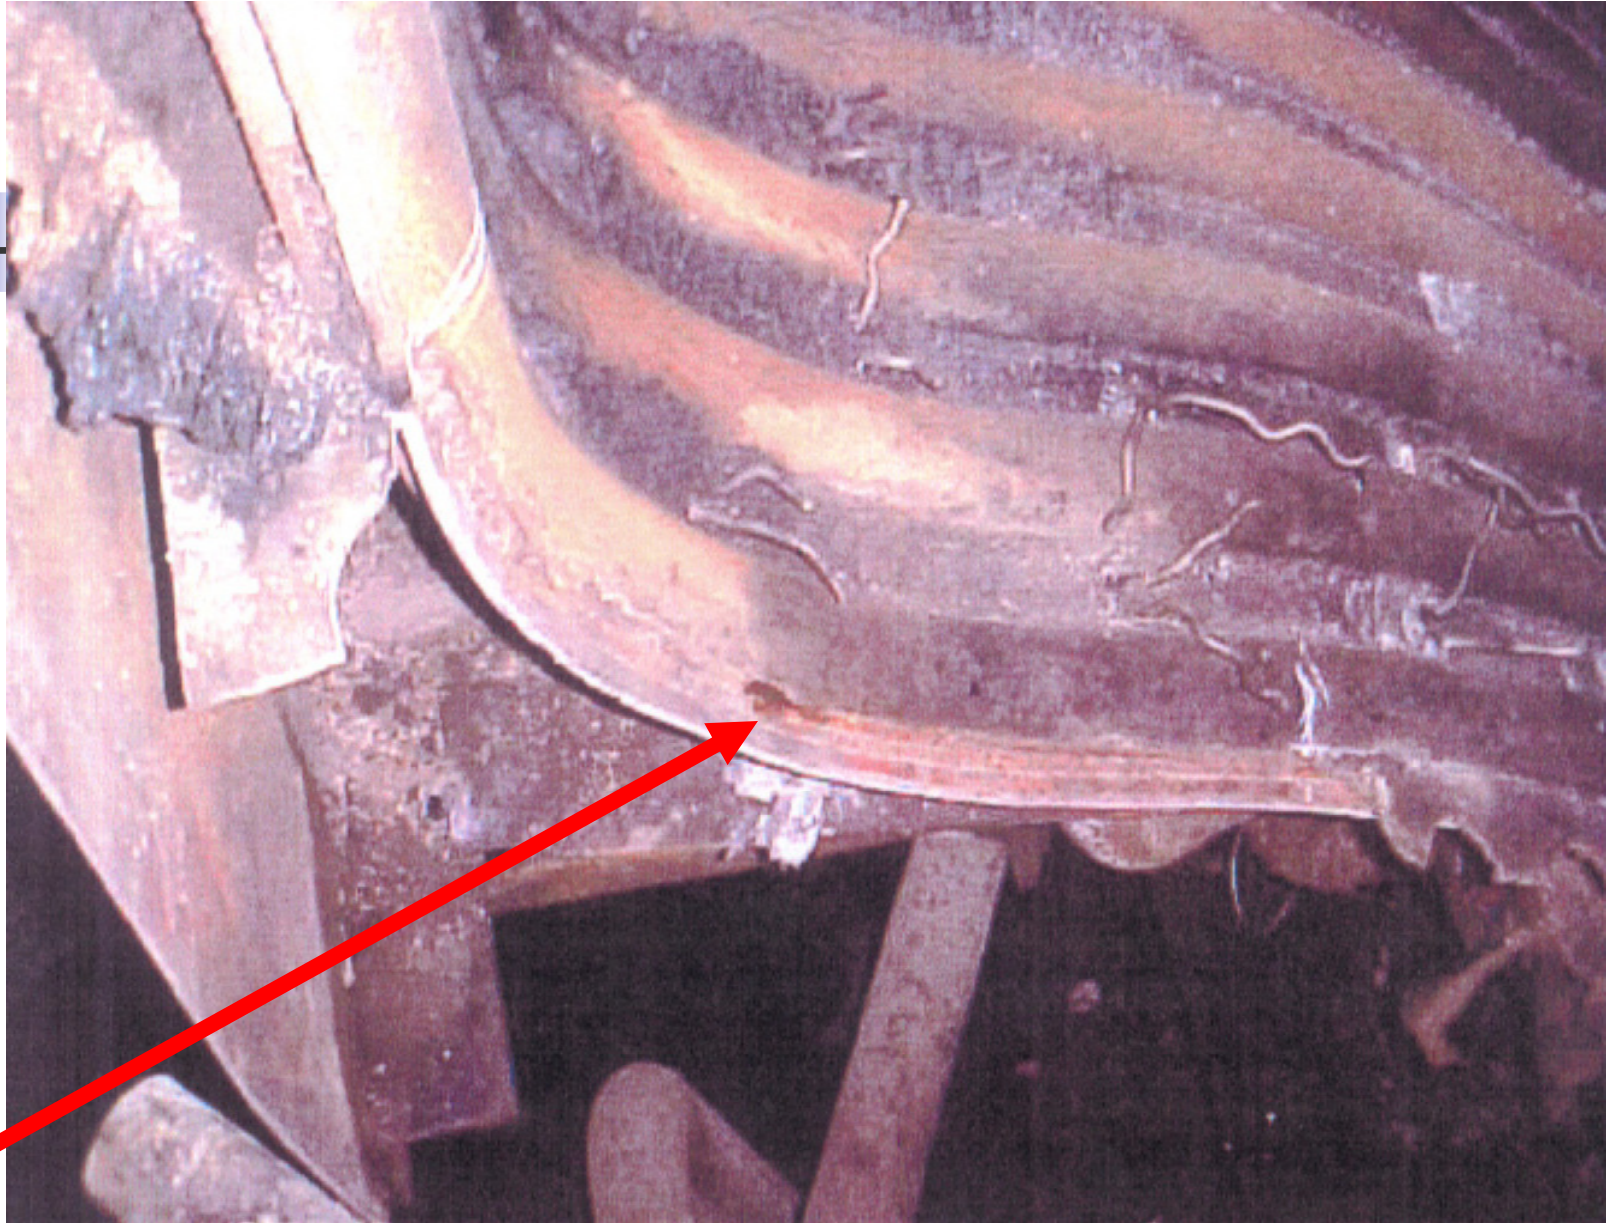
RT. FRONT
CORNER
FLOOR
TUBE

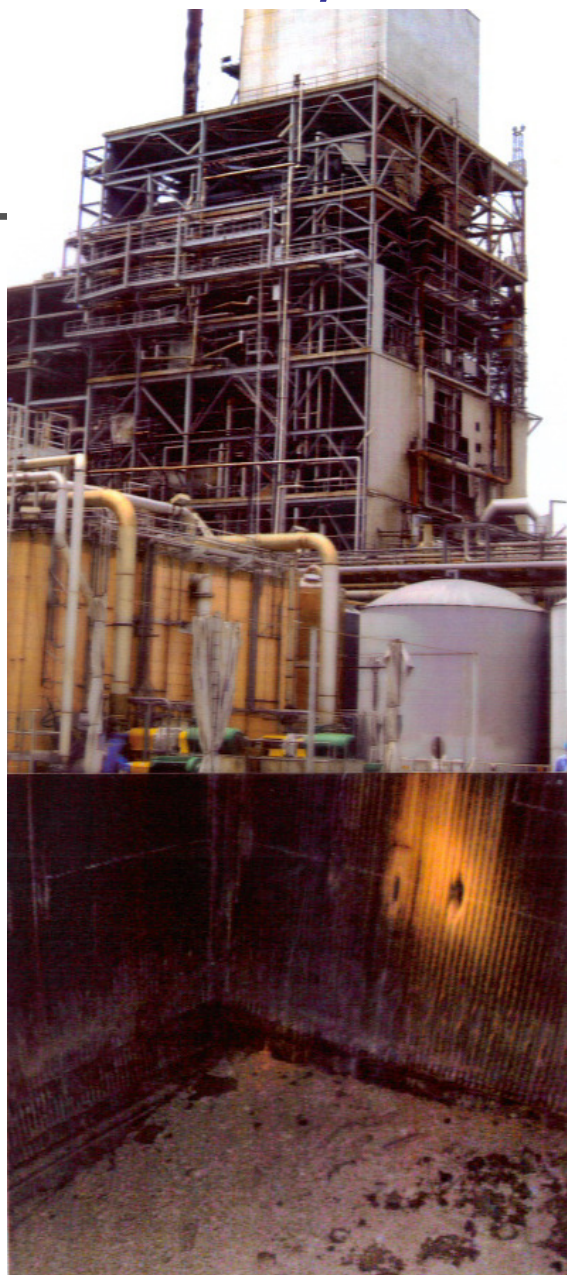
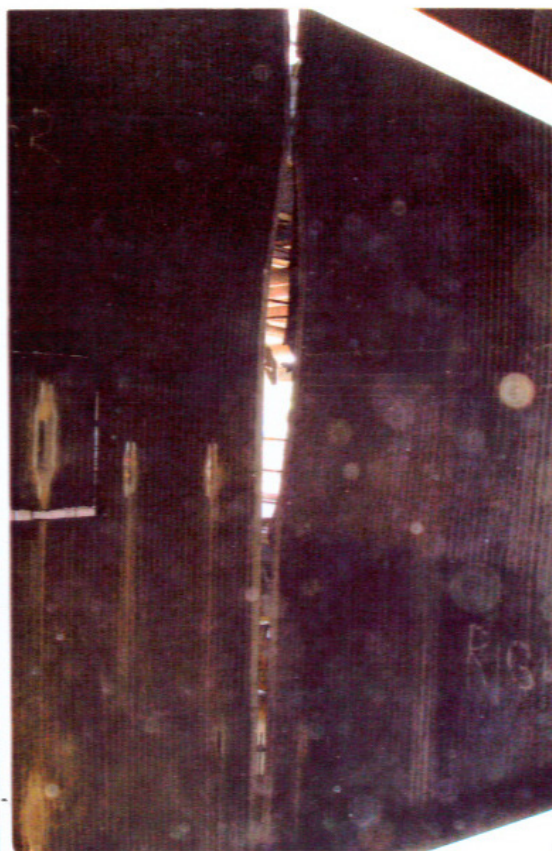
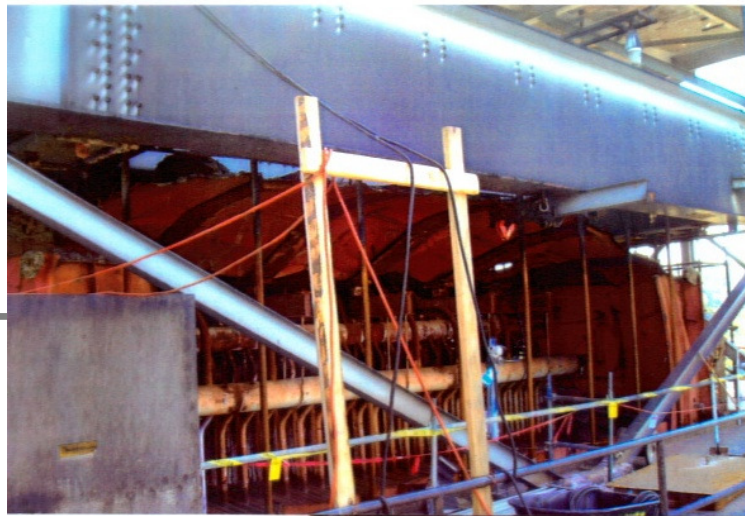
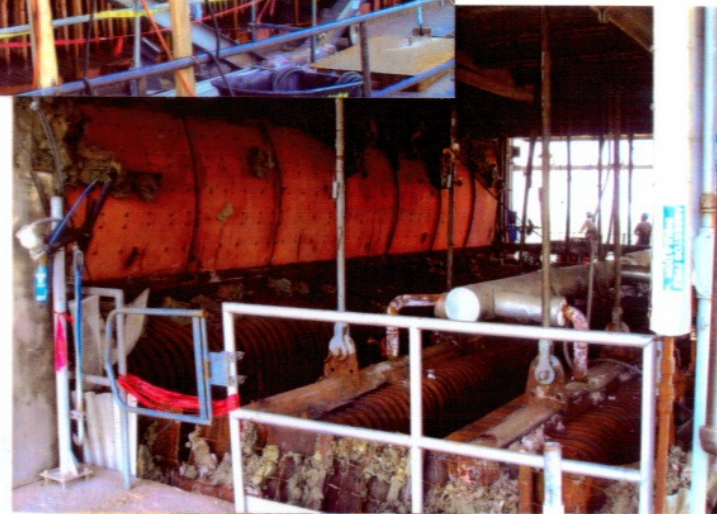
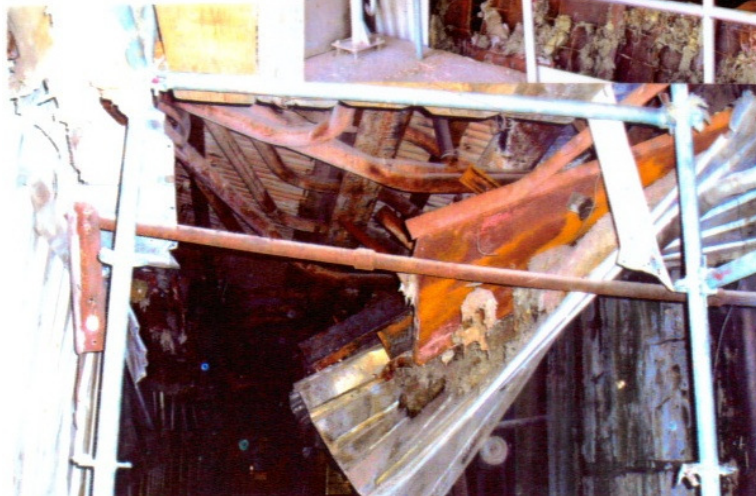
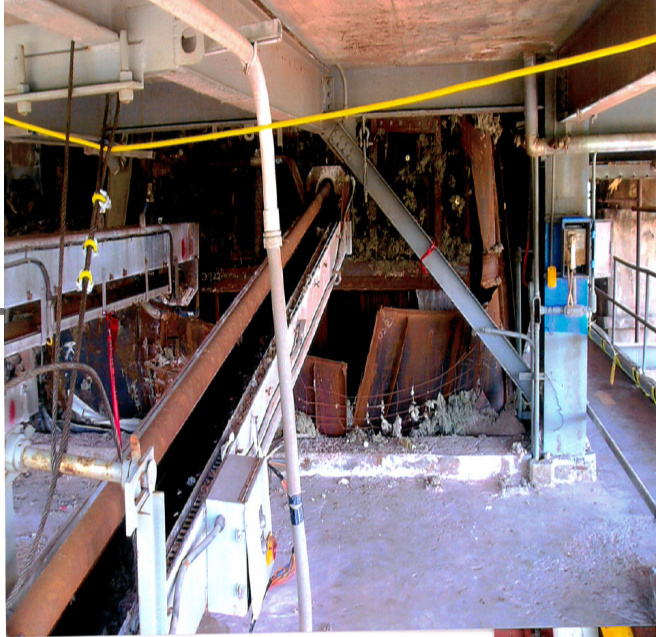
Comb. Gas/Aux Fuel Event #3 Pictures

3. Cold outage, power boilers down, package boiler in to run 400# fans with 150# steam for recovery start-up. Unit not up fully with stable headers and sent 80# steam to the evaps, explosion. Start-up burners have Class I ignitors (20% capacity) with separate combustion air and no main flame monitoring. Starved fans, speed dropped and combustibles accumulated. Extreme damage (one fatality and multiple burns), down eight months.
